NBSIR 85-3259

Nondestructive Evaluation of M732 Proximity Fuzes

November 1985

Final Report

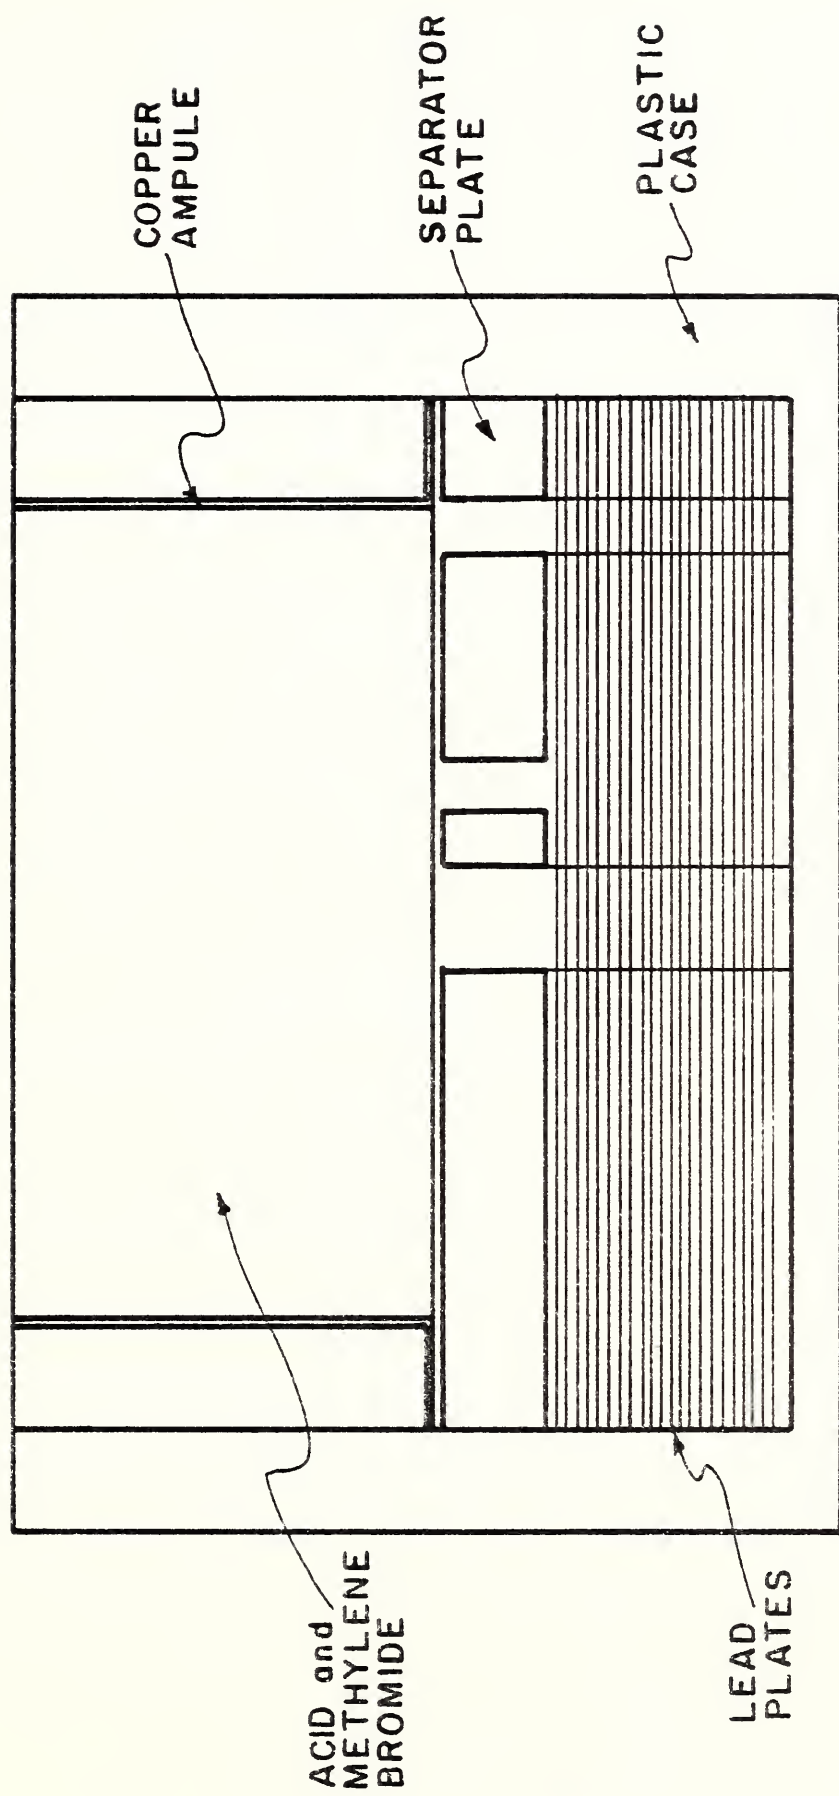
The M732 power supply is a lead-acid battery with the acid contained in a copper ampule. Upon firing, the copper ampule is punctured releasing the acid to the lead plates thus activating the power supply. A diagram of the power supply, with sufficient detail for this study, is shown in figure 1. In addition to acid the ampule contains methylene bromide as a buffering agent. Failure of these power supplies occurred when holes were etched in the copper ampule releasing the acid prematurely. An evaluation of whether one of these power supplies has failed can be done by detecting the presence of acid or methylene bromide in the volume occupied by the lead plates.

Figure 1. M732 proximity fuze power supply. (Scale $\approx 4:1$.)
Full details of the supply are not shown.

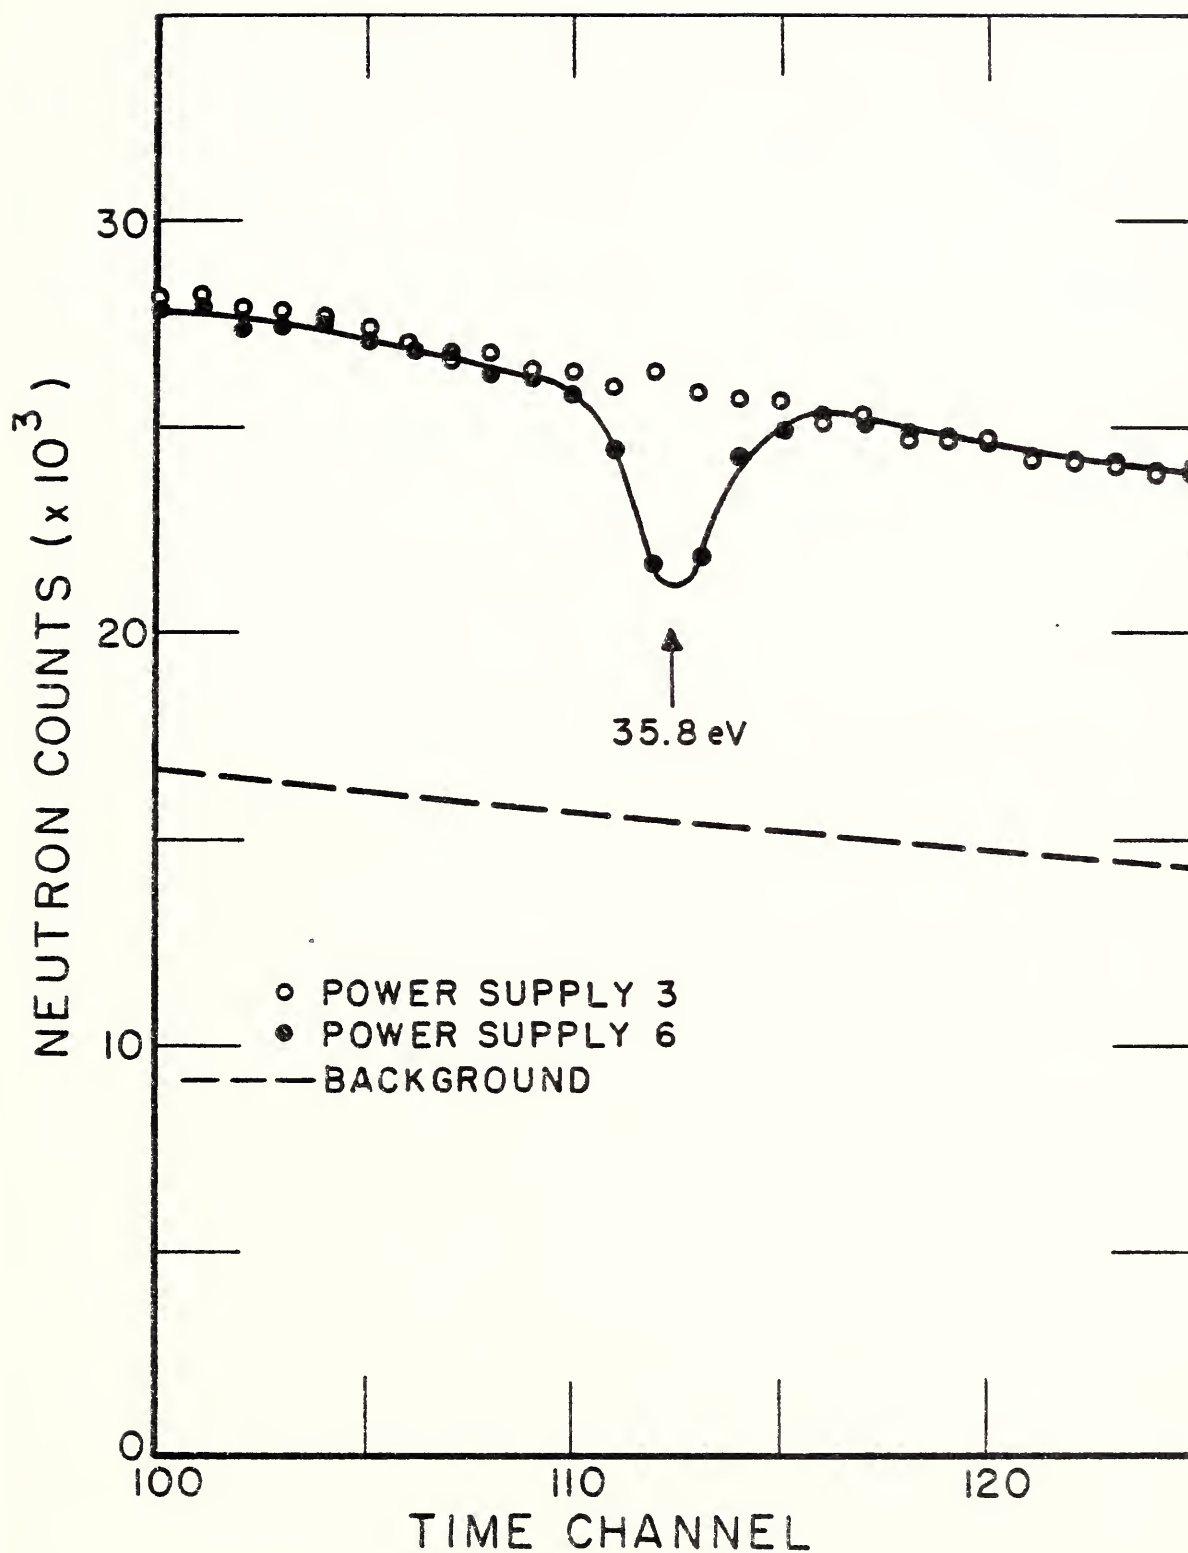
We started with a known bad supply and it was apparent within minutes that a strong 35.8-eV transmission dip was present. In figure 3 typical results for a good and a bad supply are shown. Because the overall transmission of the fuze is low, the background in these measurements is high, ~ 60%. Subtracting this background the transmission at 35.8 eV is 0.5 which implies a bromine density of 2.7×10^{-4} nuclei/b. This is nearly 50 times the expected amount for methylene bromide vapor. The conclusion is that methylene bromide is being concentrated in the area of the lead plates by some mechanism.

On a suggestion by Dr. J. Nelson of HDL we took apart one of the bad supplies and made separate runs on the plastic case and the lead plates. Nearly all the bromine signal was from the plastic case indicating that the methylene bromide is attacking the plastic and being concentrated there. Further evidence for this effect is the swelling of the plastic case in fuzes with leaking power supplies.

Figure 3. Typical experimental results for NRTA on leaking and non-leaking power supplies. The transmission dip at 35.8 eV is due to bromine.

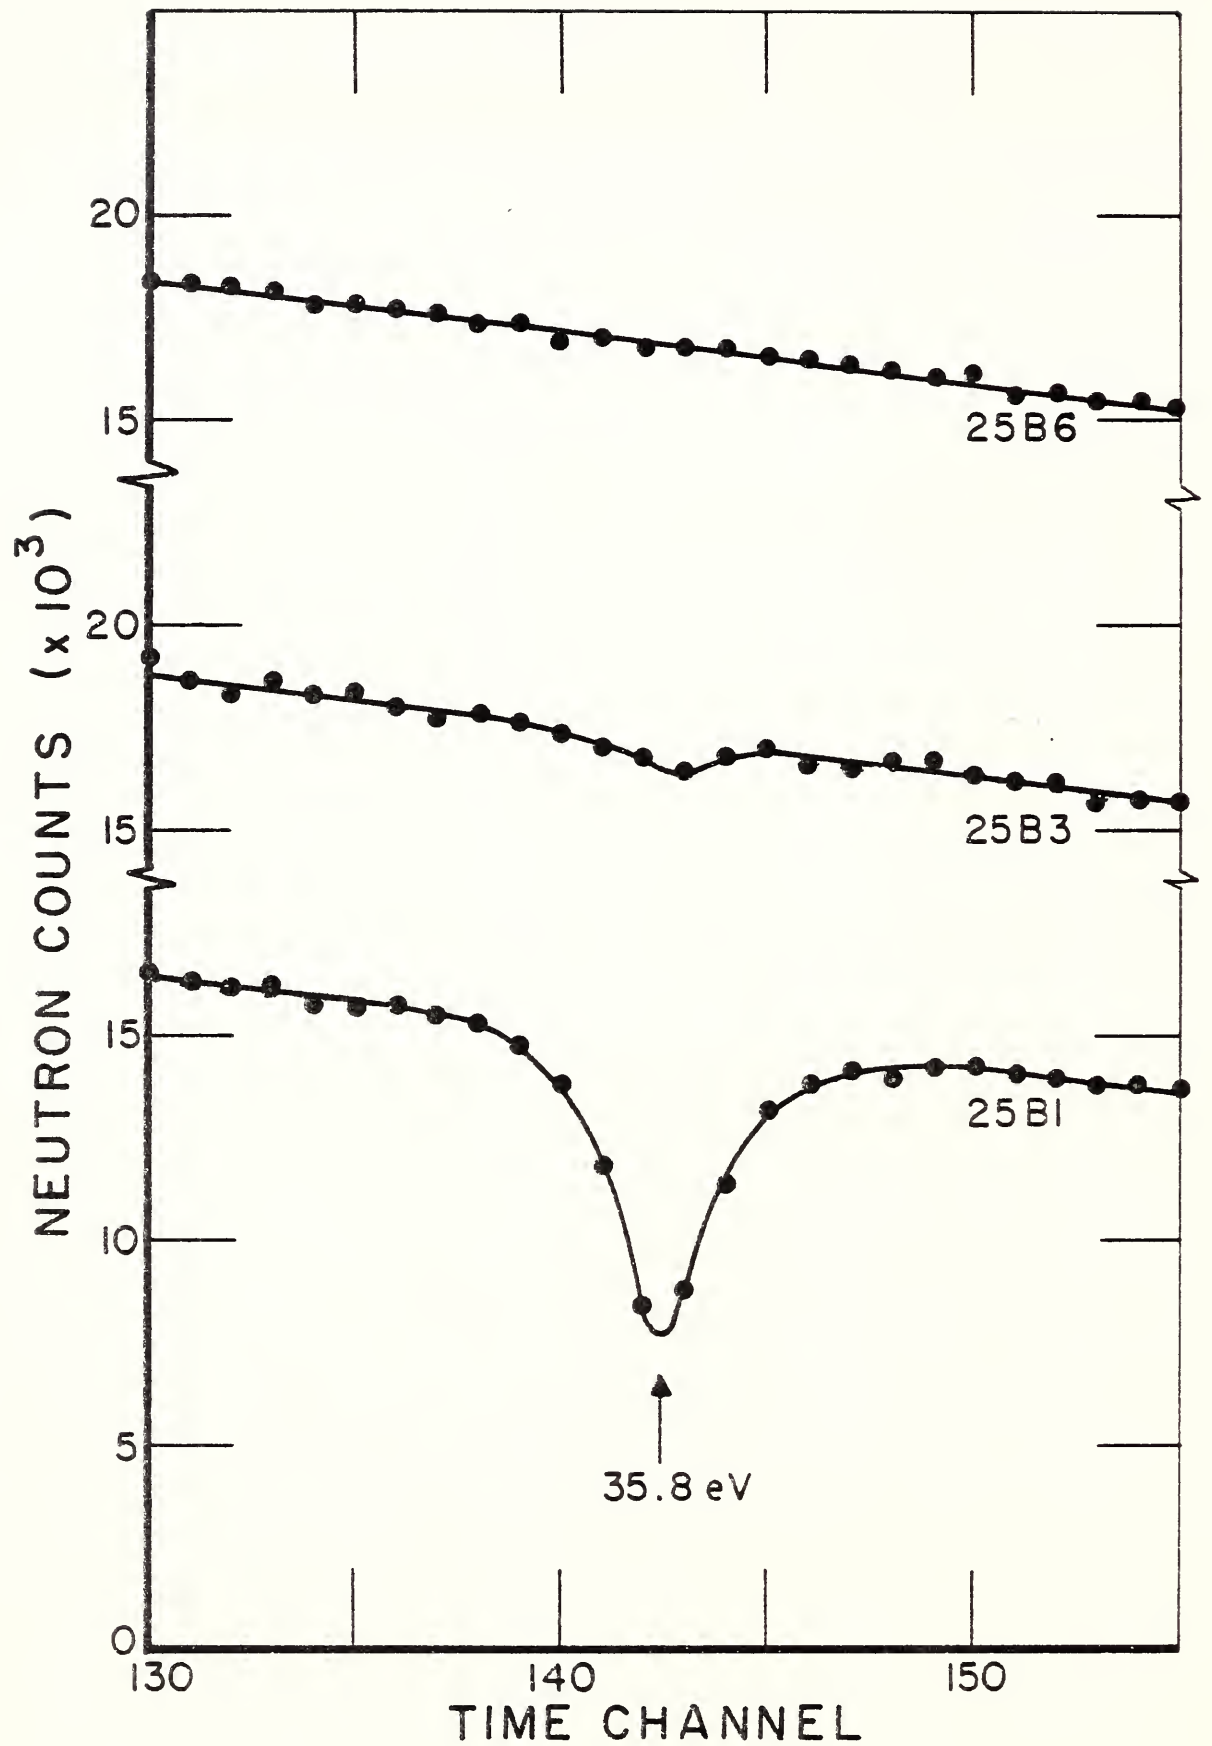
The results of these tests are summarized in table 2. In the status columns the experimental results are interpreted in terms of good or bad. However, a detailed examination of the neutron transmission data reveals two classes reported as bad power supplies. In one case large transmission dips are seen (<0.7) and in the other case moderate transmission dips (>0.9) are seen. Typical results for these two cases and for a good power supply are shown in figure 4.

Comparison of the NBS and HDL results reveals several problems. The first problem is that those fuzes with moderate transmission dips (B3, B4, and C1) identified as bad are, in fact, not bad. This misidentification is probably caused by absorption of methylene bromide from the badly leaking power supplies in the same cases (i.e., B1 and C2). Some evidence for this conclusion is the fact that the transmission is nearly the same before and after baking for these misidentified fuzes. One could probably eliminate this misidentification by setting a lower limit on the transmission. However, more experimental measurements would be required to determine exactly where to set this limit. For these runs a transmission limit of 0.85 would eliminate these misidentifications.

The second problem is that fuzes A5, B2, and D6 were found to have leaking power supplies by HDL but there is no evidence for that in the NBS measurements. However, Dr. J. Nelson found that these supplies only started to leak recently and concluded that they were forced to the leaking stage by the bakeout at NBS. Consequently, the methylene bromide probably had not had time to absorb into the plastic case. Again, further experimental tests would be required to determine how long one should wait after baking before doing neutron transmission tests.

Figure 4. Typical results for NRTA on M732 proximity fuze of unknown status. See text and table 2 for the status of these fuzes.
